THE EFFECTS OF OFF-HIGHWAY VEHICLES ON THE CULTURAL RESOURCES OF RED ROCK CANYON STATE PARK, CALIFORNIA

MICHAEL P. SAMPSON

An investigation of off-highway vehicle effects on archaeological sites and historical properties within Red Rock Canyon State Park was conducted in 2004-2006. Thirteen prehistoric occupation sites, 11 prehistoric lithic scatters, seven historic mining work camps, four prehistoric quarry sites, and one historic stage station are known to be traversed by roads and informal vehicle trails. Damage related to vehicle use consists of the following: deflation of cultural deposits, vehicle scars, loss of soils and vegetation, gullying, displacement and damage to artifacts and cultural features, and others. Soil deflation along roads and the volume of soil loss were found to be significant at certain sites. Solutions to the vehicle-caused problems could include: installation of effective vehicle barriers, closure of certain routes or route segments, public education, increased patrol by park rangers, regular maintenance of routes of travel, application of erosion-control measures, restricted access, and others.

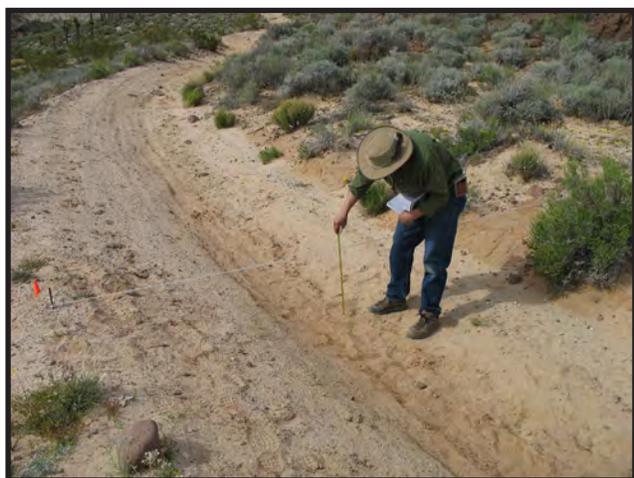
Figure 2. Recordation method for soil loss transects (taken at KER-5118).

Soil loss within a road where it passes through an archaeological site was measured, as a means to document the amount of erosion caused by vehicle traffic. From an arbitrary starting point on-site, a series of spikes were laid out at 10-ft intervals on opposite sides of the roadway on unaffected ground (Figure 2). A long tape measure was extended between the two spikes, and depth measures were taken at 1-ft intervals within the roadway. A profile of the road surface is thus produced, and measurements of soil loss can be calculated using the recorded figures. This technique for measuring soil loss is outlined in an article by Dr. Howard Wilshire (2000). Erosional gullies of appreciable size found within roads at archaeological sites were photographed, measured, plotted with a GPS receiver, and placed on park maps.

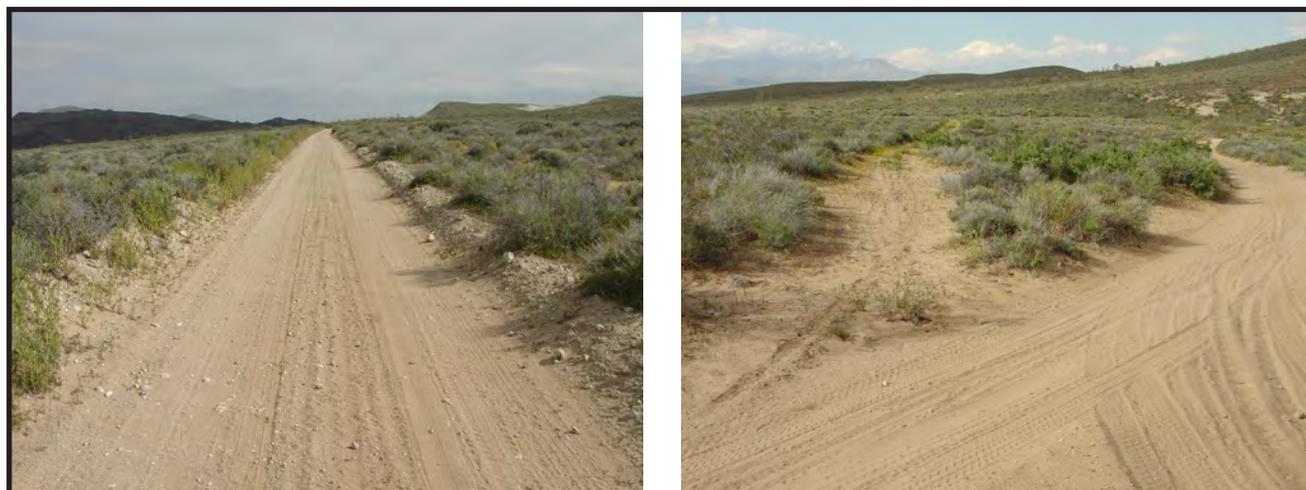
Figure 3. (a, left) KER-377, Old Dutch Cleanser Mine Road cutting through site, 4/7/05, (b, right) KER-377 at top of Steep Trail. Note unauthorized OHV trail at left, photograph taken April 7, 2005.

Steep Trail crosses KER-377, a large lithic scatter site, for approximately 500 ft or 152 m, and there are numerous chert and chalcedony artifacts visible within its surface. The down cutting effect of continued vehicular use upon the terrain with loose, sandy soils is considerable and readily apparent (Figure 3). At the junction of the latter two roads, Steep Trail has two paths that converge just less than 55 ft or 16.7 m below Old Dutch Cleanser Mine Road. One vehicle route measured 14 ft or 4.3 m in width; the other measures 19.5 ft or 4.7 m in width. A measure of deflation here showed Steep Trail measured 2.76 ft or 85 cm lower than unaffected terrain. This vehicle-caused deflation creates a significant loss of cultural deposits from KER-377.

An informal, unauthorized, lightly used motorcycle trail leads off from Steep Trail and cuts through site KER-377 for a distance about 1,275 ft (Figure 3). The informal trail lies 0.91 ft or 28 cm below the unaffected terrain on KER-377. The informal OHV trail measures 8.5 ft or 2.6 m in width.

A permanent barrier, such as a few large boulders, and a small sign are needed to block the unauthorized trail. The installation of water management features on the closed unauthorized trail is also recommended. The portions of the unauthorized trail lacking plant cover probably should be

scarified using a hand crew to help promote seed growth.

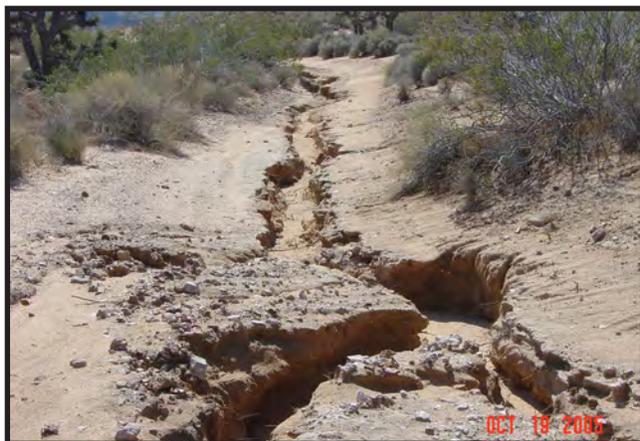
Figure 4. Severe erosion on Steep Trail at KER-376.

Steep Trail has extraordinary erosional damage in which large gullies or channels were deeply cut into the trail tread (Figure 4). Measurements of new erosional channels cut into site KER-376 along Steep Trail taken at selected places were as high as 36 in (90 cm) wide and 20 in (51 cm) in depth. The depth of Steep Trail below the undisturbed ground surface where no gullying occurred is .82 ft (25 cm). Depth measurements taken with the automatic level at two locations within newly formed erosion gullies were 4.64 ft (142 cm) and 2.37 ft (73 cm). These indicate a significant loss of sediments from the site. Artifacts and cultural features were exposed in the areas of erosion.

Just south of KER-376, Steep Trail takes a steep drop down the slope toward KER-5118 and beyond to the bottom of Last Chance Canyon. The current ongoing pronounced erosion on this abandoned section of Steep Trail can be arrested with a control of water volume and velocity within the trail tread. The source of water at the top of the slope (the south edge of archaeological site KER-376) must be broken, and then work down the slope. Excavate breaks in the road shoulder berm on the east side of Steep Trail measuring about 3 to 4 ft in width at intervals of about every 100 to 150 ft. These breaks will serve as a useful interim erosion-control measure by pulling water off the abandoned and eroding trail tread. The sediment from the berm breaks should be pulled onto the tread of the abandoned trail. Check dams of local rock serving as sediment traps can be built within the deepest gullies on the trail.

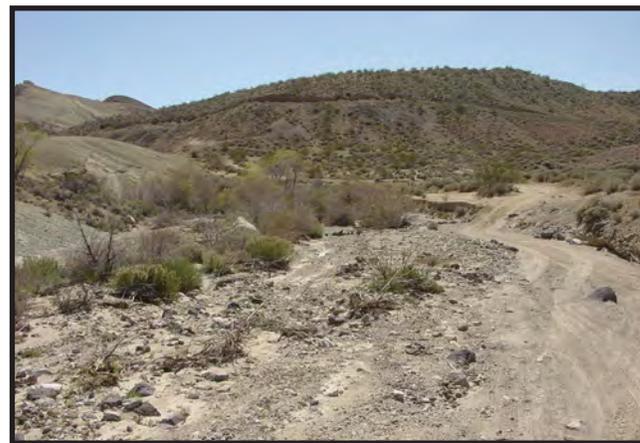
Figure 5. OHV trail in middle Last Chance Canyon with KER-6258 at right, site KER-6237 in background, and KER-5951 ("Grubstake Hill") on hillside in background. Taken on 3/23/06.

Four archaeological sites, KER-6259, KER-6258, KER-6237, and KER-6235/H (Cudahy Camp), were found to be situated directly within the existing OHV route as it passes through the middle portion of Last Chance Canyon. This section of Last Chance Canyon (Figure 5) has a viable riparian zone with year-round surface water and a well-developed growth of riparian trees and understory plants.

Our knowledge of the archaeological resources within the middle portion of Last Chance Canyon, as well as the sensitive natural values and geologic features, point to vehicle closure as the best alternative for optimum site protection and preservation of the riparian zone. A closure of a relatively short section of middle Last Chance Canyon would still allow vehicle access to this part of the park. Park visitors in vehicles could drive south through the upper portion of Last Chance Canyon, access the canyon from the south off of Redrock-Randsburg Road, or, access the middle of the canyon via Pleasant Valley Road. Detailed biological surveys should be conducted within Last Chance Canyon.

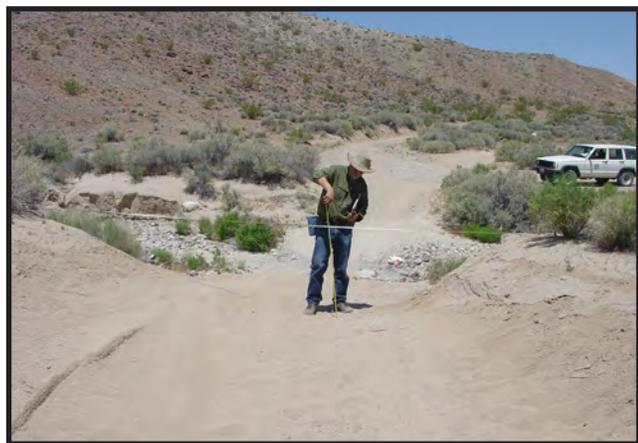
Figure 6. OHV Trail as it traverses KER-6237, view to south-southeast. Tape has been strung horizontally to depict the unaffected ground surface. Site KER-6258 lies in background. Photograph was taken on 5/10/06.

Soil loss transects were established and measured along the existing OHV route that now traverses site KER-6237, and the loss of soils at this location was found to be significant. The OHV trail measured up to 35½ in. (90 cm) deeper than the undisturbed portion of the site (Figure 6). The volume of soil lost within the 55-ft-long transect within KER-6237 was determined to be 481 ft³. The loss of soil extrapolated along the entire length of the OHV trail where it passes through the site (246 ft) calculates to 2,151.38 ft³. That figure represents a significant amount of cultural deposits lost to vehicle use.

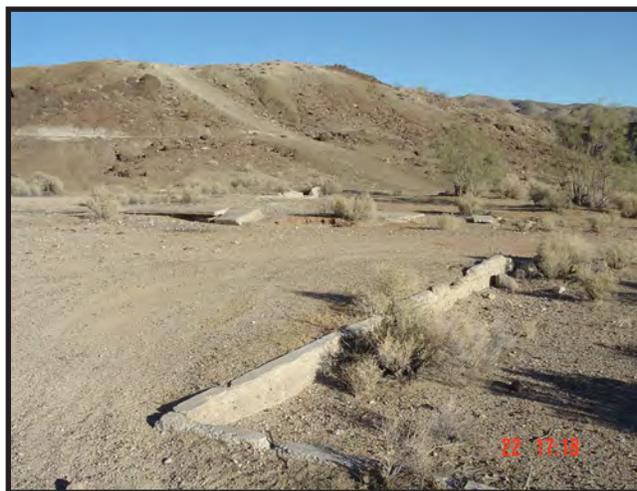
Figure 7. Cudahy Camp impacted by modern-day camping and vehicle activity.

The site of Cudahy Camp has been impacted by modern-day camping and vehicle activity (Figure 7). Illegal target shooting occurs at this location and trash is left on-site by campers. The site has now been closed to camping. OHV users perform unauthorized hill climbs on the edge of the residential area that leave the bare slopes scarred and highly susceptible to erosion.

The site of Cudahy Camp (KER-6235/H) has been damaged by OHV travel on-site, camping, littering, target shooting, and other unregulated visitor activities. Vehicle barriers, erosion-control devices, and revegetation (where feasible) are needed on the unauthorized hill climbs on-site and the OHV trails heading onto the alluvial terrace where the site lies. Routine patrol by park rangers and other field staff is difficult but possible. (The park has prohibited camping here since this study was completed.)
